TT00013

Tuliped Intake Valves Shortly After Rebuild On Gasoline Engines

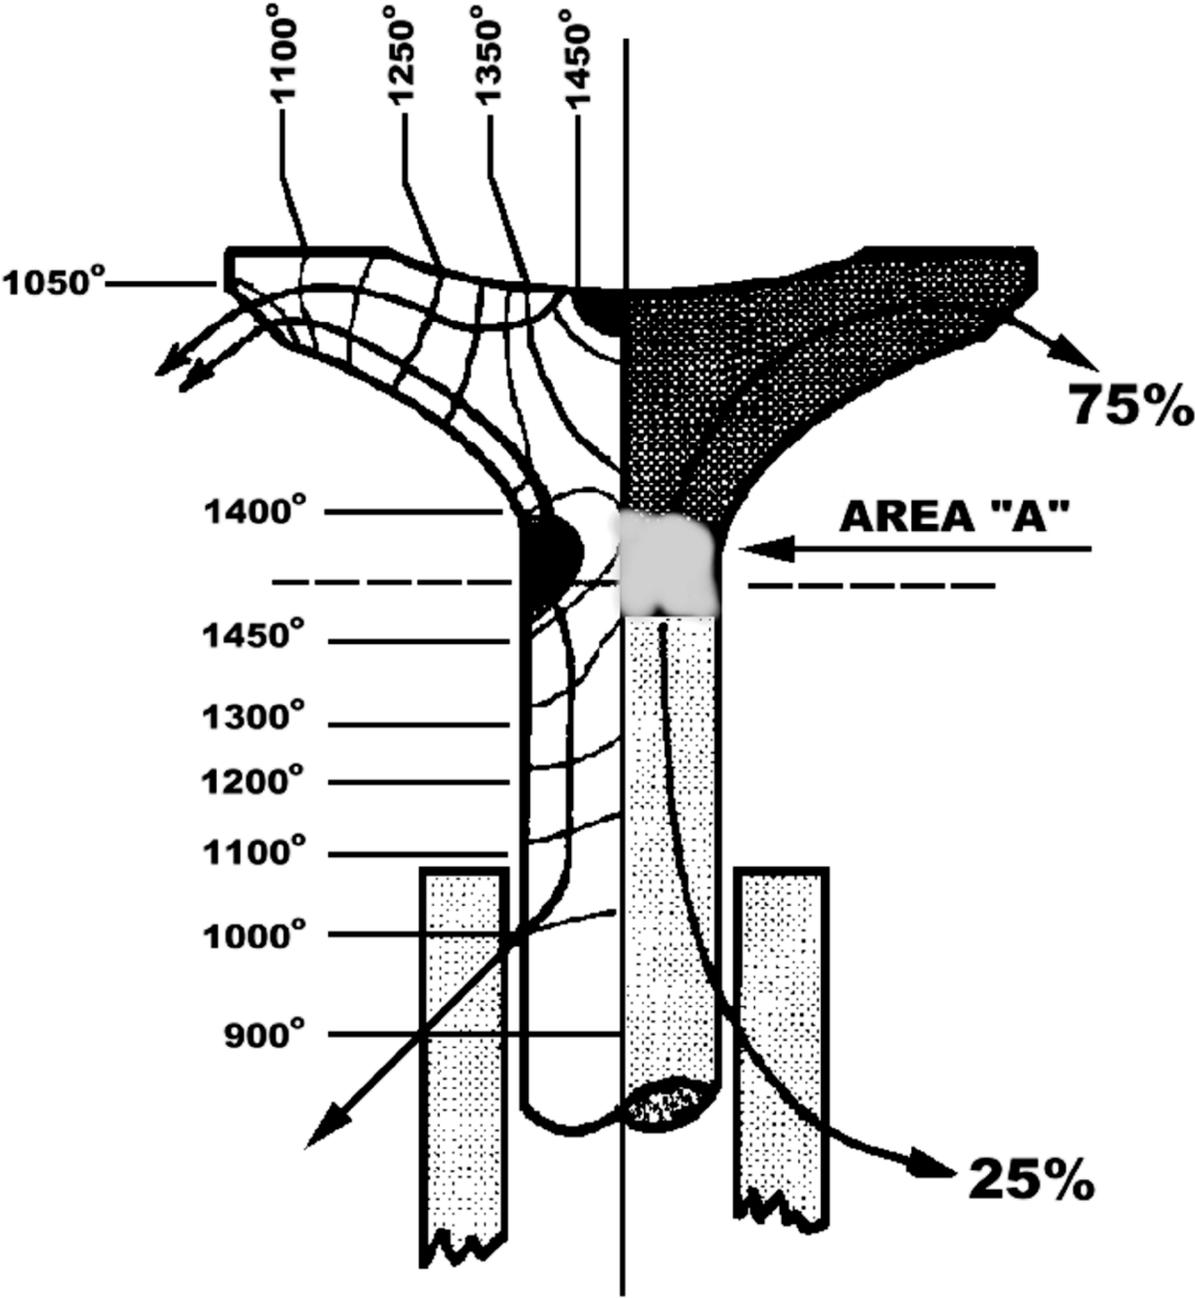
Combustion chamber temperatures that have exceeded the engine's original design parameters usually may cause a tuliped intake valve. Each valve used in an engine has a specific requirement, which results in different materials for intake and exhaust valve locations. Design engineers will specify which materials will economically work best for the intake and for the exhaust locations.

Figure 1: Valve Head Temperatures - FAILURE ANALYSIS

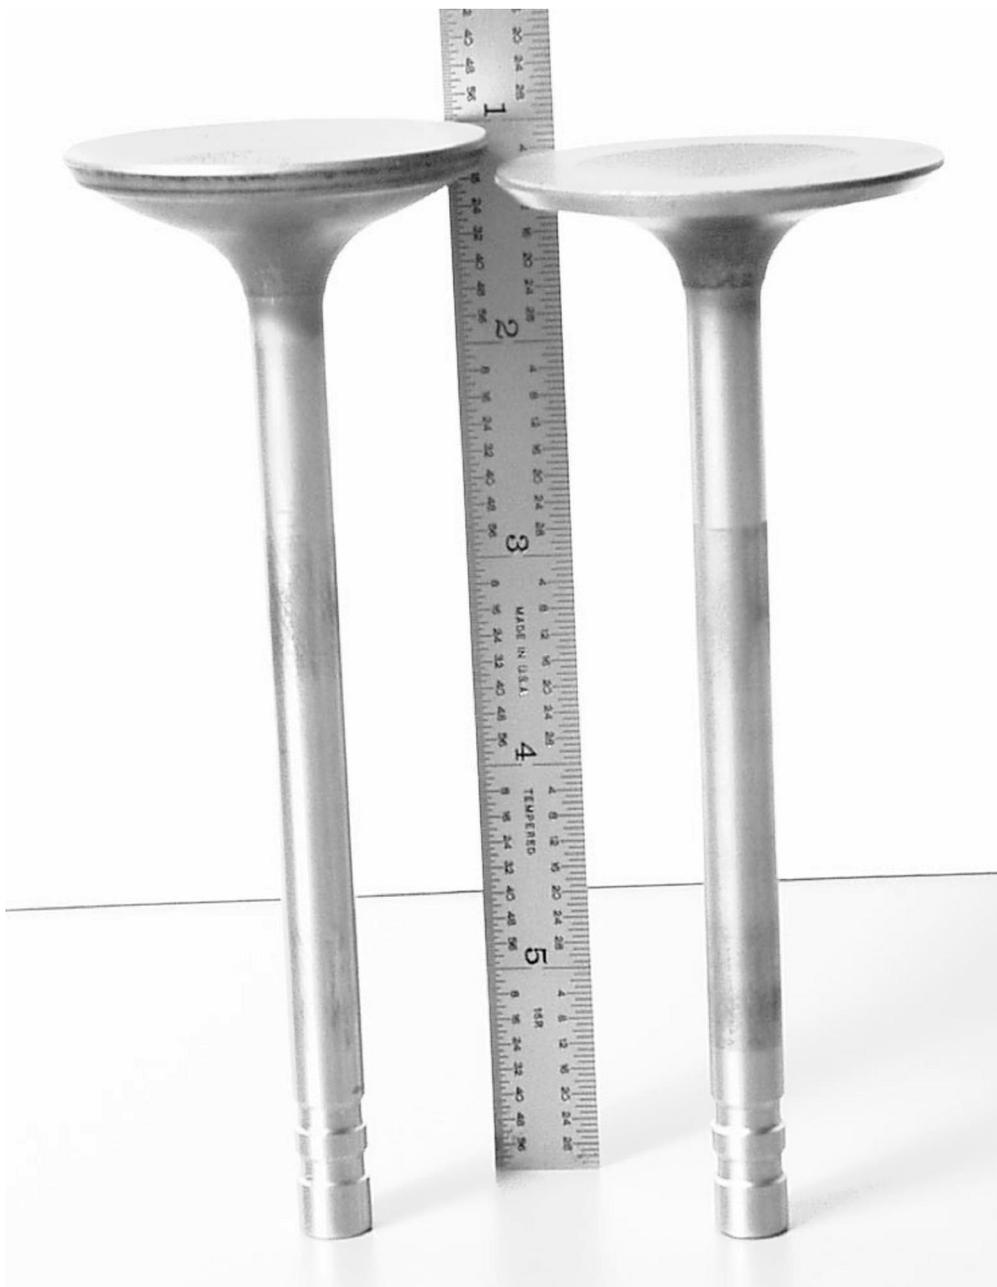
The two intake valves shown in Figure 2 are both out of the same engine. The one tuliped valve is .220" longer than its original length. This was the result of an abnormally high combustion chamber operating temperature. This temperature is in the cylinder of the engine, NOT THE ENGINE COOLANT TEMPERATURE. The temperature surrounding the valve got much higher than the valve was ever designed to withstand. That excessive temperature resulted in the valve material softening, allowing the valve head to stretch to create what is called a "tulip" shape.

An abnormal combustion process may increase the operating temperature in the combustion chamber as high as 5000° F with pressures between 3,500 - 5,000 psi. If this "tulip" condition re-occurs after rebuilding of the engine or reconditioning of the cylinder head, the original problem has not been fixed. This condition may affect one or more valves at a time.

Figure 2: Valve Length Comparison - FAILURE ANALYSIS

Items to check: properly working EGR system, correct ignition timing, ECU operation, vacuum leaks (intake manifold, hoses, etc.), correct air to fuel mixture, correct angles between the valve and the valve seat, excessive valve spring pressure and any other source that affects the combustion process.
