Valve Failure Clues: Read 'Em and Weep

By Ted Tunnecliffe

Engine Builder Magazine, August 2001

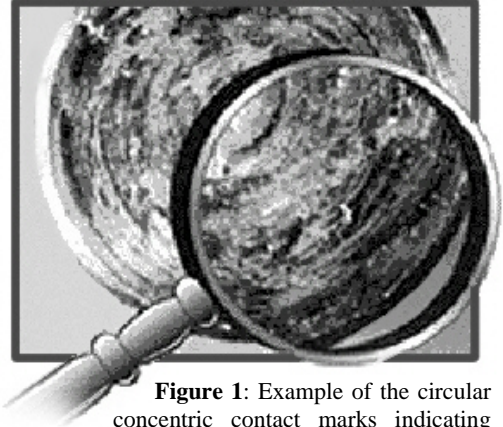
Valve activation is normally the result of action by some sort of opening method like a rocker pad or similar component. Such parts frequently leave witness marks behind, and that is what we are looking for. On a valve tip, that mark may be vague concentric circles of varying diameters as in **Figure 1**.

Figure 1: Example of the circular concentric contact marks indicating that the valve has rotated against the rocker pad during operation.

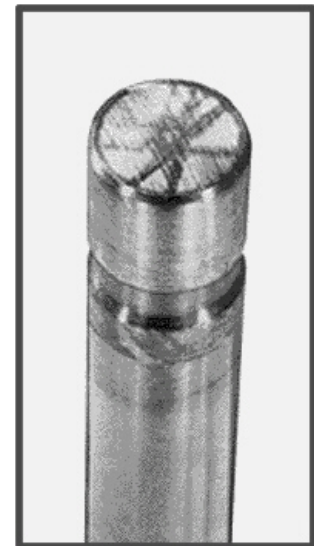
The photo in **Figure 2** is an example of the contact patterns on a valve that did not rotate in a push rod engine. You might also see a "bow tie" pattern where only two such rocker pad patterns are visible.

Figure 2: Example of contact pattern on valve tip indicating that the valve has oscillated instead of rotated against the rocker pad.

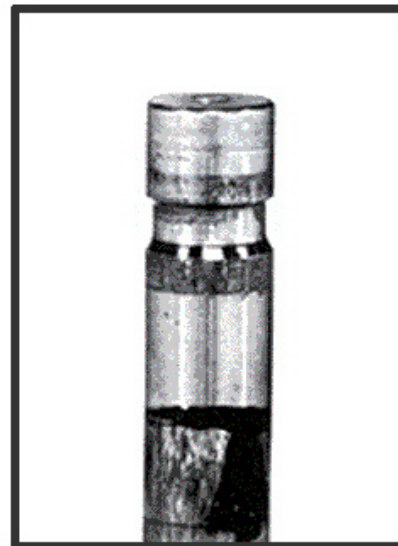
In two-valve engines, intake valves – because they are of a larger diameter than the mating exhausts – are frequently more susceptible than are the exhausts to "float" or "toss" due to their heavier weight. They may not fail more quickly, however, because the exhaust may be weaker due to its higher operating temperature. **Figure 3** shows an example of a chafed valve groove area.

So what causes this erratic valve motion? A weak valve spring, an improperly assembled valve gear, a valve stem sticking or, as is frequently the case, engine overspeeding. If the engine is designed to red line at six grand and you run it up to eight, good luck, but don't come crying about your broken valves.

Figure 3: Chafe marks at the side of the groove indicating that the valve has been bouncing instead of following the cam

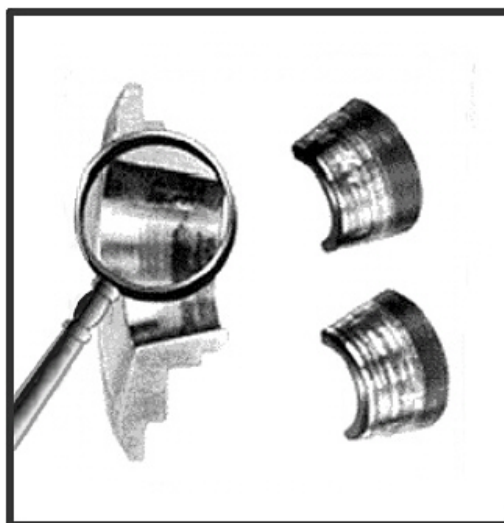
In addition to the contact marks on the valve itself, if you happen to have the keys and retainers to look at, you can sometimes get some good information from them, too. That is particularly true of the keys. On their I.D., if you can see scuffing and chafing marks they should match those on the valve. Take a look; it may very well confirm your initial analysis. On the keys in **Figure 4** we can see the O.D. chafing and the match up of it to the chafing on the I.D. surface of the retainer. You can put this one to bed.

Figure 4: Circumferential chafing pattern on both the spring retainer and the valve keys indicating movement relative to each other during operation,

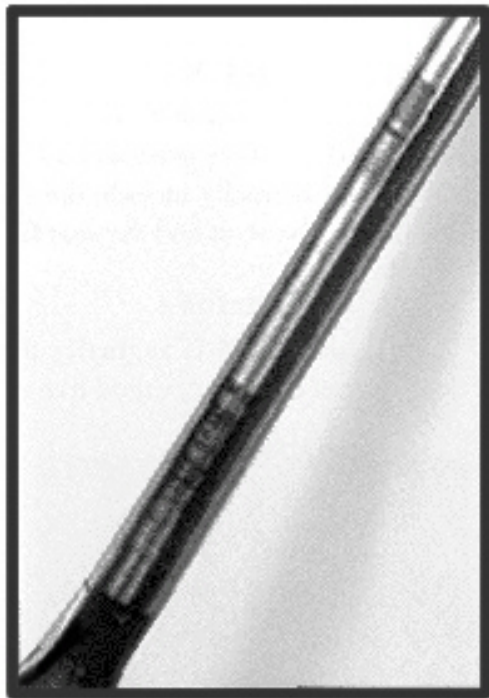
Figure 5: Contact patterns on a valve stem indicating its movement within the valve guide.

The photo in **Figure 5** shows an example of the patterns we are talking about.

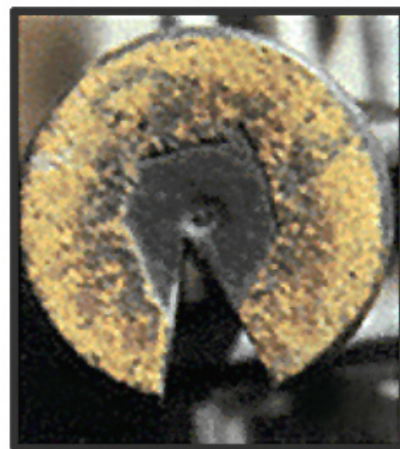
Lead in the gasoline and the PbO (lead oxide) deposits on valves and most diesel fuels are equally controlled and are designed and tested to death. That wasn't always true, of course, but now about the only thing we have to show you here is some old stuff. And even in those old days intake valves experienced very few of these problems because they ran so cool. If, by chance, you do see engines that have run on leaded gas you may see the kind of attack in the underside of the valve head that is shown in **Figure 6**.

Figure 6: Tetraethyl lead corrosion on an exhaust valve head face caused by fuel oxidized by the combustion process forming lead oxide deposits on the valve head.

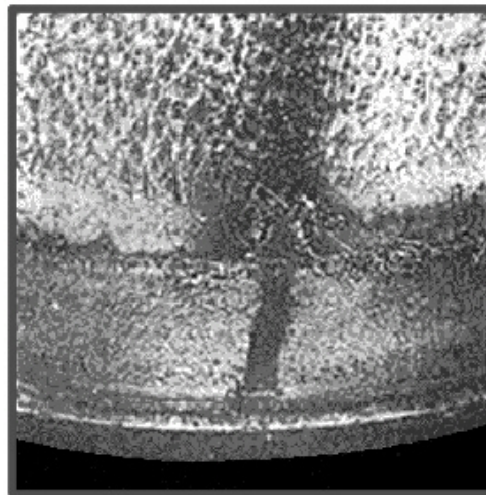
An exception to that would be if you see evidence of leakage as in **Figure 7**. This happens to be a heavy-duty diesel job, and you can see the leak path across the seat face. The leak path is actually the removal of combustion deposits from a localized area. What are those deposits? In modern diesels, the burning of lube oil in the combustion chamber typically forms them. If it goes on too long, the temperature of that leaking gas will begin attacking the metal and you end up with a guttered valve seat face. In this case, the metal beneath the deposit had not yet been affected by that leakage.

Figure 7: Seat face of a diesel exhaust valve showing leakage through a crater in the normally present oil combustion deposits. The leakage is evident by the groove itself and by the carbon trail on the valve fillet surface above it.

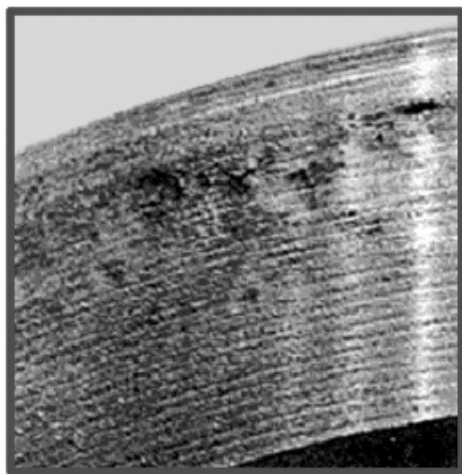
Figure 8: Seat face of an operational valve that has been removed and carefully cleaned at the surface to remove combustion deposits. The “diamond lines” from the dresser going in and out of the pits prove that the pits are indentations, not corrosion pits.

The photo in **Figure 8** shows the seat face of a valve after it had run in an engine for a considerable period of time. Although I don’t remember just how long, the point of this picture is to show the roundish depressions that can be seen on the seat face.

The circumferential lines are called “diamond lines” and are caused by dressing the seat grinder too fast. It is a single point diamond dresser. In this case, it was very fortunate that they were there, although ordinarily the valve should have been rejected at visual inspection. We carefully cleaned the valve so as not to disturb the surface, and examined the valves.

Those diamond lines, because they went in and out of the depressions, allowed us to confirm that the depressions were actually indentations as we suspected rather than corrosion pits. The problem with the valve alloy was identified as insufficient high temperature hardness and not poor corrosion resistance.
