Technical Bulletin

K-Line[®]

Subject: Guideliner Broaching Process and Tooling

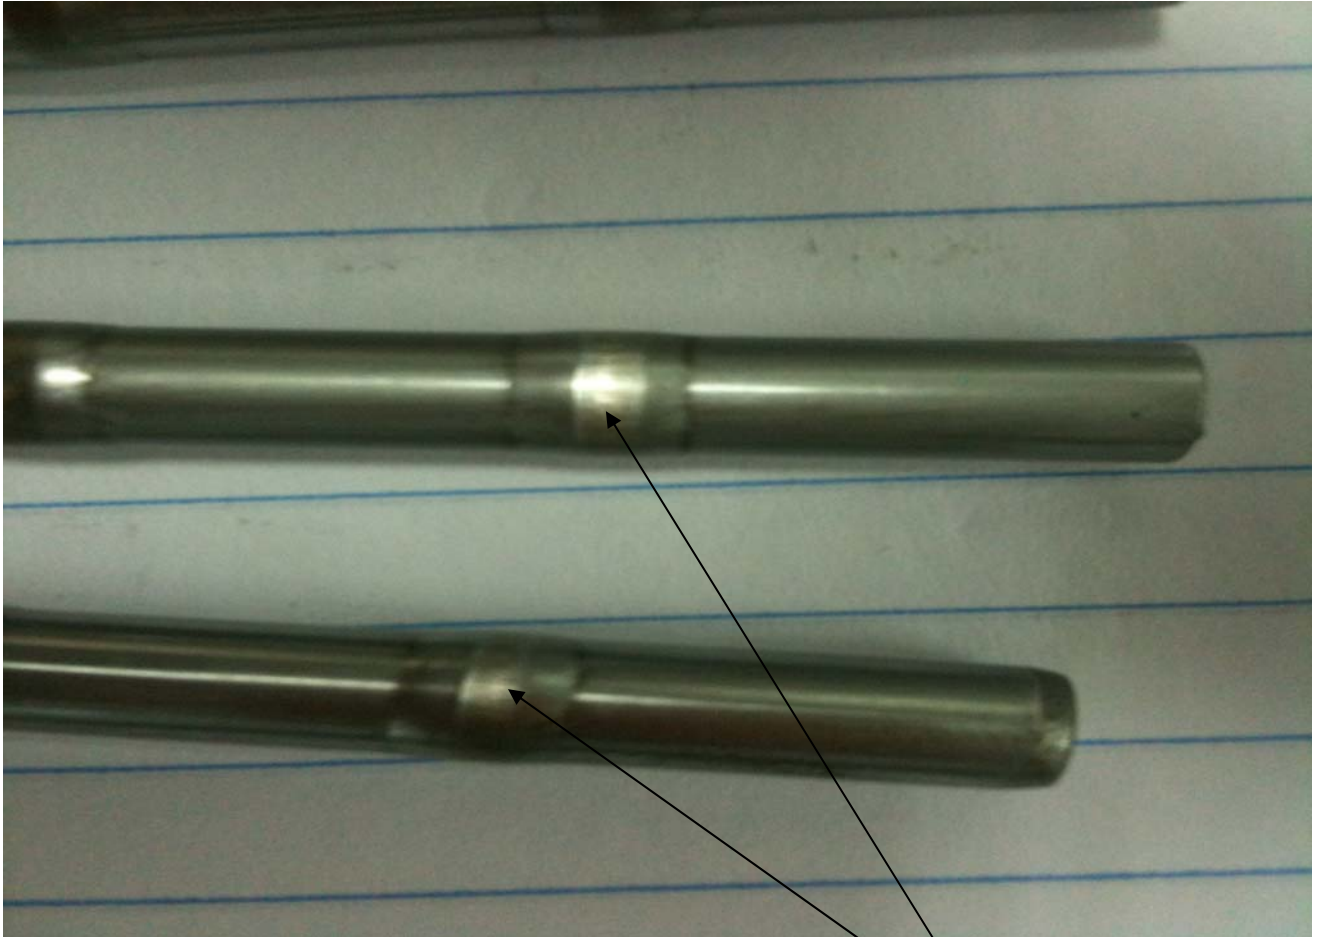
This picture shows severely worn broaches. The Bronze color on the sizing sphere of the broach is Liner material embedded in the surface. This tool will cause a lot of damage to the liner.

When the chrome plating shows signs of wear, the broach needs to be replaced ***immediately!***

It is recommended to lightly oil the broach before starting the broaching process. The Recommended Bronze-Lube part # KL1224 is ideal for this purpose and will extend the life of your broach and is available ONLY at the Nashville Warehouse. To order, please call 1-800-843-7328.
