TT00034

Valve Guide Liner Broaching Process And Tooling

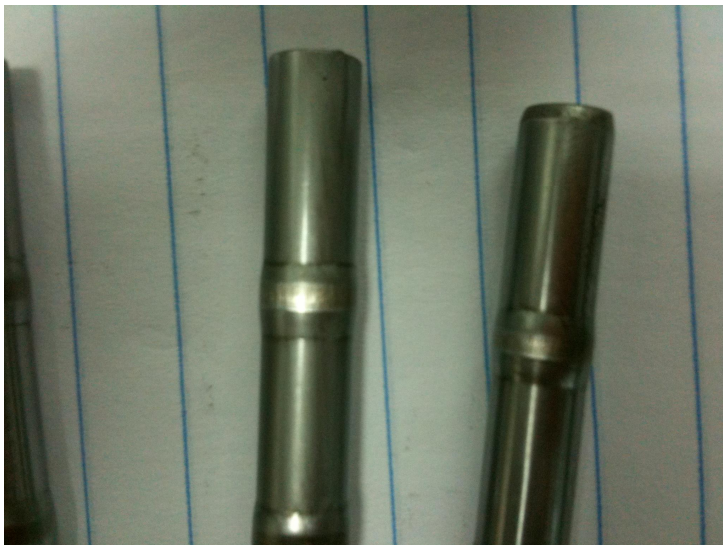
This picture shows severely worn broaches the goldish color on the sizing sphere of the broach is Liner material embedded in the surface. This tool will cause a lot of damage to the liner.

When this occurs the broach needs to be replaced immediately not doing so will cause that the liner gets pushed out of the guide during the broaching process. Or worst it will scratch the ID of the bronze

It is recommended to lightly oil the broach before starting the broach process Bronze-Lube KL1224 is ideal for this purpose and will extend the life of your broach.
