Analysis of High Speed Natural Gas Engine Valve Vibrations Using Statistical Methods

By Fred Oliva, Senior Hardware Engineer &

Dynalco, Division of Crane Corporation, Fort Lauderdale, Florida, USA

This paper was presented at the 2008 Gas Machinery Conference. It is reprinted with permission.

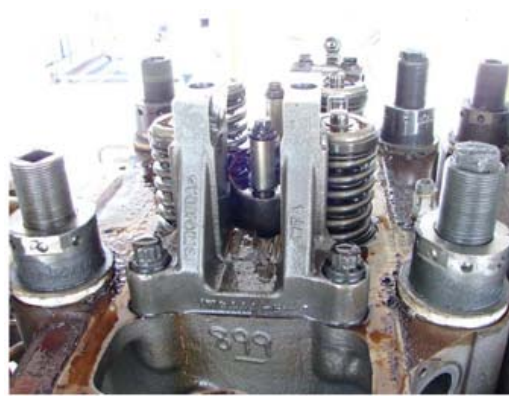
Figure 2.1

Natural gas gathering applications typically use 4-stroke engines with either 2 or 4 valves per cylinder as the prime mover. **Figure 2.1** (below) depicts the basic cylinder head/valve layout. An accelerometer is typically used to gather vibration data from the valve events.

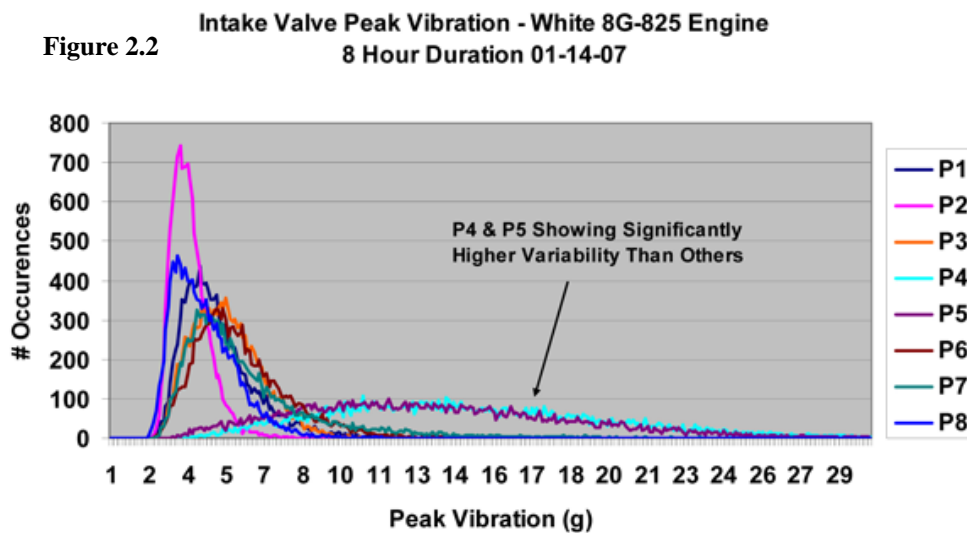
The valve variability plot shown in **Figure 2.2** (below) shows a histogram of intake valve closing events for a White 8G-825 engine.

The data for this study was taken over an 8 hour period. The peak vibration for the valve closing events is plotted in a histogram format. The X-Axis (Peak Vibration) indicates peak vibration values in g's for a given closing event.

The Y-Axis (# Occurrences) indicates the number of times that a specific peak vibration value occurs over the 8 hour test period. Valves with a narrow pattern, such as P2, indicate that the peak closing valve vibration is more consistent over multiple cycles. Valves with wider patterns indicate that the closing vibration is less consistent over multiple cycles. It can be seen that intake valves for P4 & P5 have higher variability than the others.

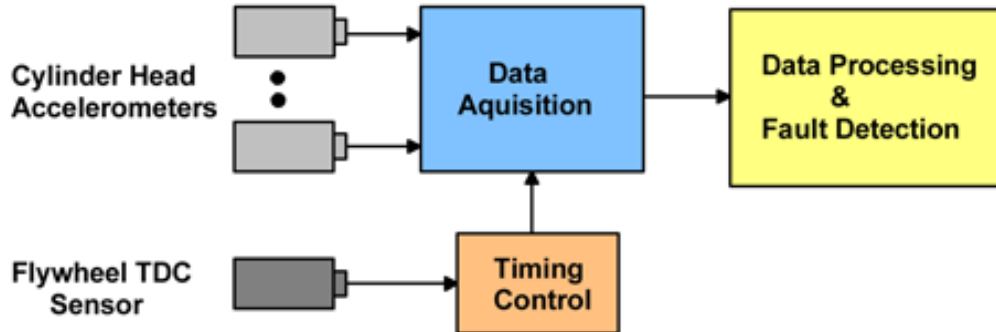
Cylinder head accelerometer data is recorded for each degree of flywheel rotation over a long period of time. Events, such as intake valve closures (IVC), and exhaust valve closures (EVC), which occur during a specific window of the flywheel rotation, are detected. The peak vibration values of these events are determined, and written into a data storage element for each cylinder. The diagram in **Figure 3-1** shows the data acquisition and analysis system that was used.

Figure 3-1 Data Acquisition / Analysis Block Diagram

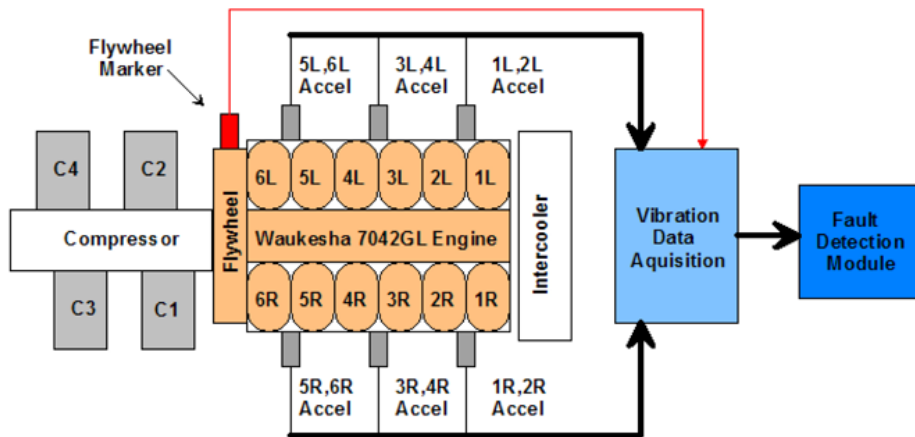
The placement of the accelerometer sensor on a V12 configuration is typically done as shown in **Figure 4-1**. Note that a single accelerometer is used for 2 adjacent cylinders.

Figure 4-1 Accelerometer Placement on a V-12 Engine

The Data Acquisition/Fault Detection System was mounted on a Waukesha 7042GL engine. This is a turbocharged, lean burn V-12 engine rated for 1488HP@1200 RPM. Accelerometers were mounted between cylinders using studs. Figure 7-1 (below) shows the engine used for testing. Figure 4-1 shows the accelerometer layout for this engine.

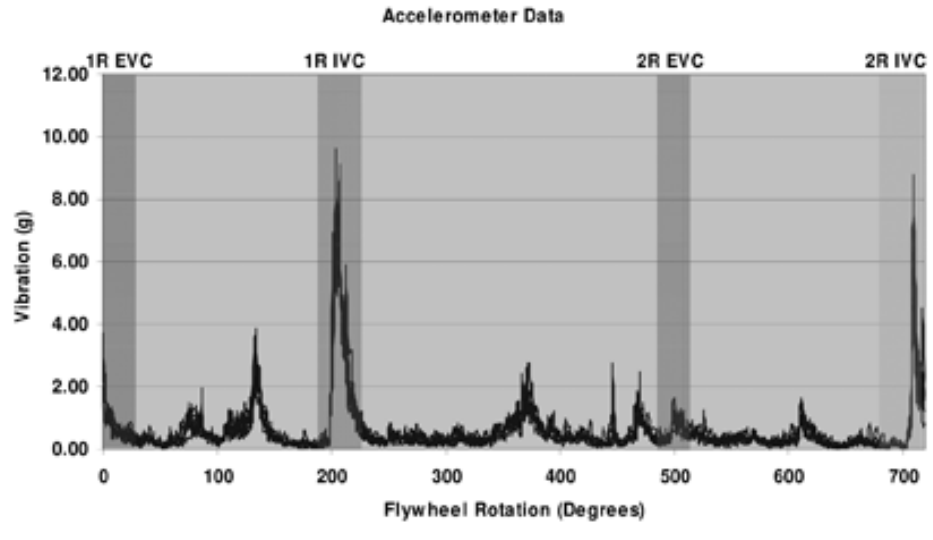
the statistical calculations allow the system to generate detailed information about each type of event of interest, such as valve closures. **Figure 4-2** (below) shows typical data that would be collected on a V-12 four stroke engine, and the windows defined for IVC & EVC events within that vibration pattern.

Figure 4-2 - Typical Vibration Data Captured on a V-12 Engine

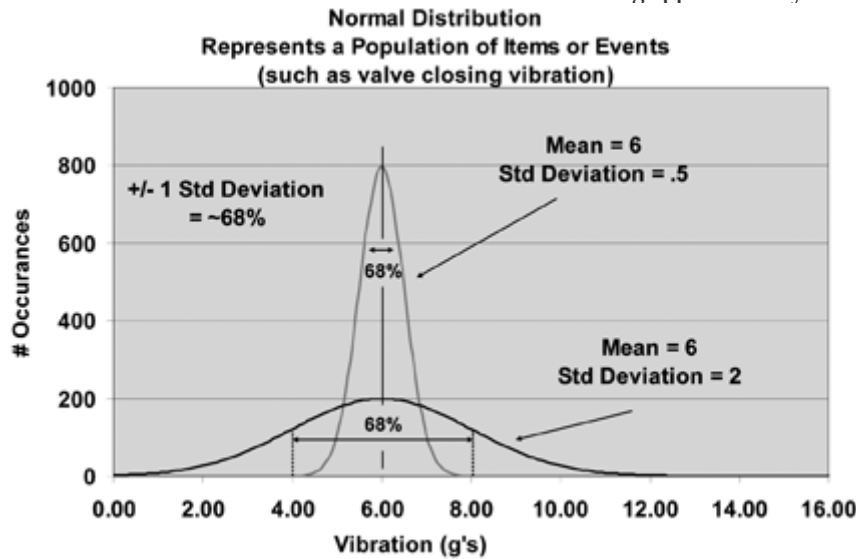
An example of a normal

distribution is shown in Figure 5-1 (left). The chart shows the mean of the valve closing event is 6 g's. Two sets of data are drawn on the chart. The first set has a standard deviation of 0.5 g's and spans from 5.5 to 6.5 g's. A second curve

represents data with a much larger standard deviation of 2 g's. It also shows one standard deviation from the mean by spanning from 4 to 8 g's. Note that the second curve represents data with a significantly higher degree of variability.

In previous studies of vibration data[1] it has been shown that the collected vibration data is bounded to a normal distribution of events. A normal distribution of data will have a bell shaped curve spanning approximately plus and minus one standard deviation from the mean and containing approximately 68% of the data.

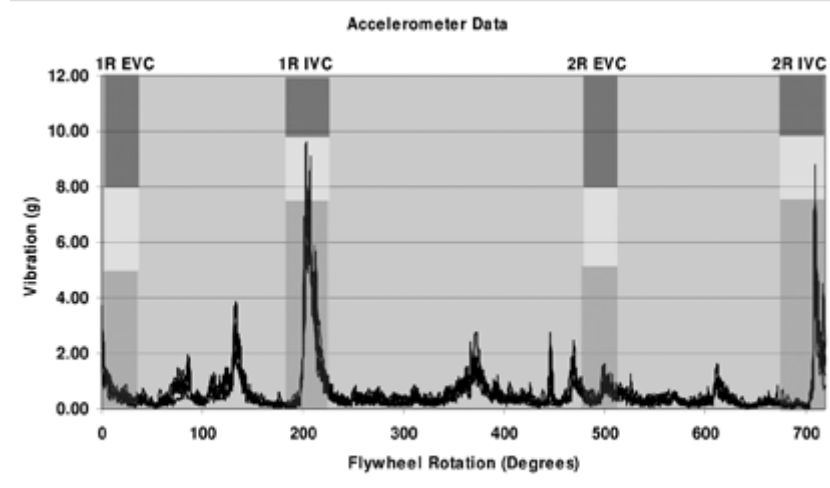
Figure 6-1 - Fault Detection Operating Bands

bands can be set individually for each event or applied to a group of like events. As can be seen in Figure 6-1 (right) which shows an example of operating bands, the intake & exhaust closing events have been grouped as like events. Note that different types of events can produce different normal, warning & alarm level bands. The Fault Detection Module will then use a patented algorithm to determine when an event crosses into a particular operating band.

An assumption is made that mechanical events will follow a normal distribution. The Fault Detection Module will use the normally distributed base line data which contains a mean and standard deviation for each event and establish operating bands of normal (green / med. gray), warning (yellow / lt. gray) and alarm (red / gray) for an event. The bands are created by using configurable multipliers of the

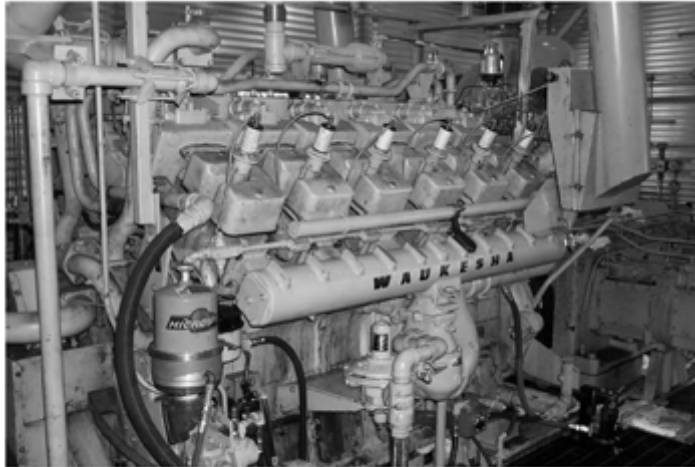
Figure 7-1 – Waukesha 7042GL Engine Used for Testing

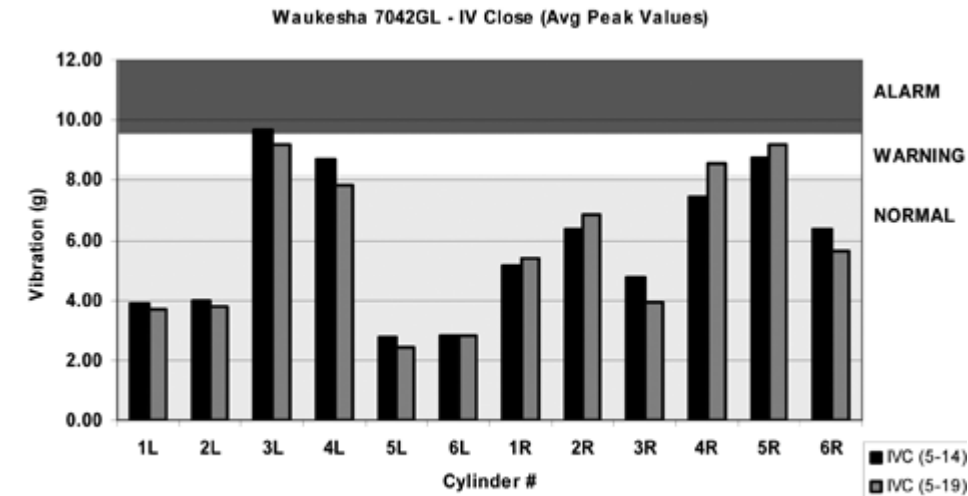
Once the system was turned on, the alert limits for warnings & alarms were defined using the statistical technique & baseline generation described in a previous section. Decisions made by the Fault Detection Module are based on data gathered over extended periods of time. This insures that brief periods of high vibration are not reported as faults. The data gathered in Figure 7-2 & Figure 7-3 are snapshots of the data used by the Fault Detection Module. Average vibration levels are plotted for each cylinder head, as well as the normal (green), warning (yellow) and alarm (red) levels determined by the system.

Figure 7-2 & Figure 7-3 show data recorded at different dates. This was done to determine that the results were consistent over extended periods of time.

It can be seen from the data that intake valves 3L, 4L, 4R, & 5R have been identified by the Fault Detection Module as having higher vibration levels compared to the other valves in the engine. It can also be seen, that, 4L & 4R were, at different dates, not identified as problems by the Fault Detection Module. This phenomenon has been seen on other occasions where a failing component, early in the progression of that failure, will sometimes exceed the alert threshold, and sometimes it will be just below this threshold.

In addition to the faults seen in the data in Figure 7-2 & Figure 7-3, additional faults were reported on exhaust valves 1L & 3L. These were not seen in the data snapshots due to the fact that their behavior was not exceeding an alert threshold when the data was taken.

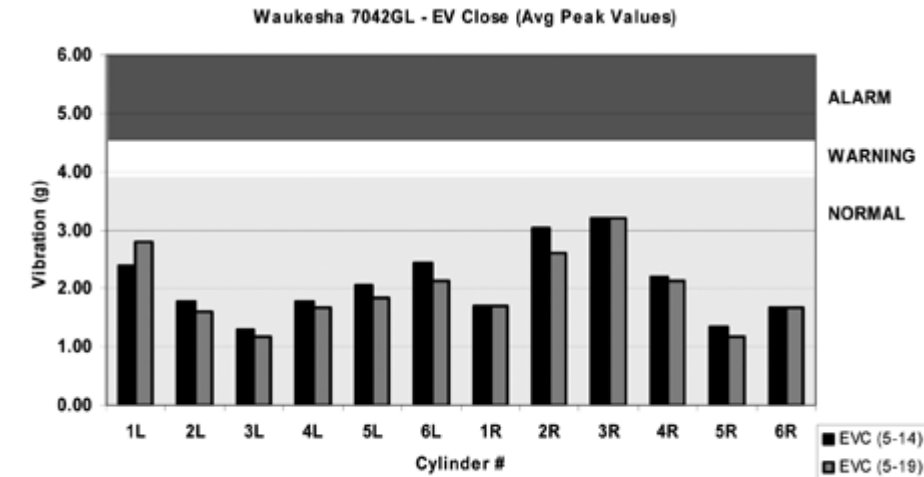
Figure 7-3 - Exhaust Valve (EV) Closure - Summary of Vibration Levels

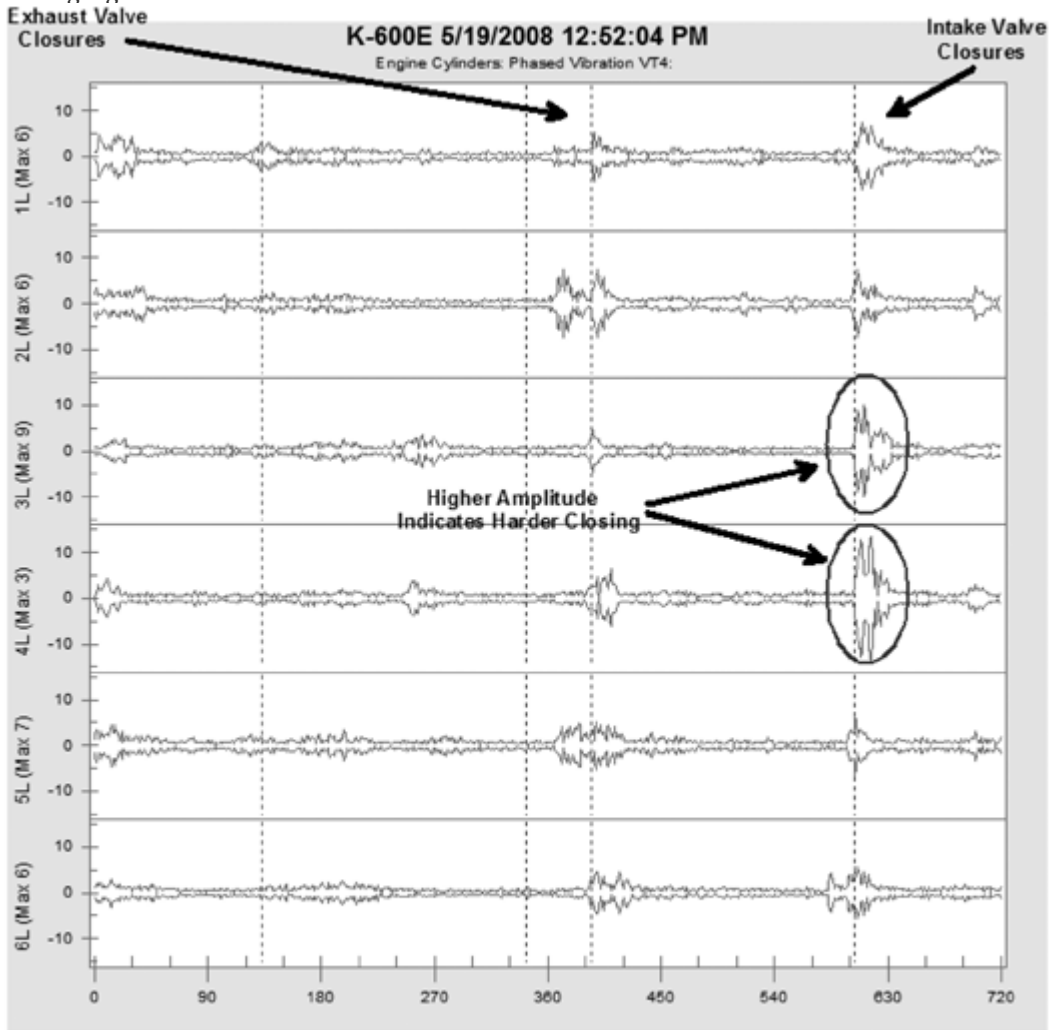
The portable analyzer vibration data for the left bank (Figure 7-4) show cylinders 3L & 4L have higher vibration values for the intake closing events. The Data Acquisition/Fault Detection system reported these same intake valves as having higher vibration values.

Figure 7-4 – Left Bank Vibration Data from Portable Analyzer (Max Values)

In order to prove that the Fault Detection Module was correctly reporting valve problems, a portable analyzer was used to take data on the engine. Figure 7-4 & Figure 7-5 (below) show the portable analyzer vibration traces used to determine how well they correlate with results from the Fault Detection System.

Exhaust valve event data from the portable analyzer show that no valves are closing harder than expected. The Data Acquisition/Fault Detection System indicated exhaust valves 1L & 3L as having harder closing events on an earlier date, then after a period, reported their behavior as normal. Subsequent inspection of the valve train for EV 1L & 3L indicated that the lifters appeared to collapse then recover for a period of time.

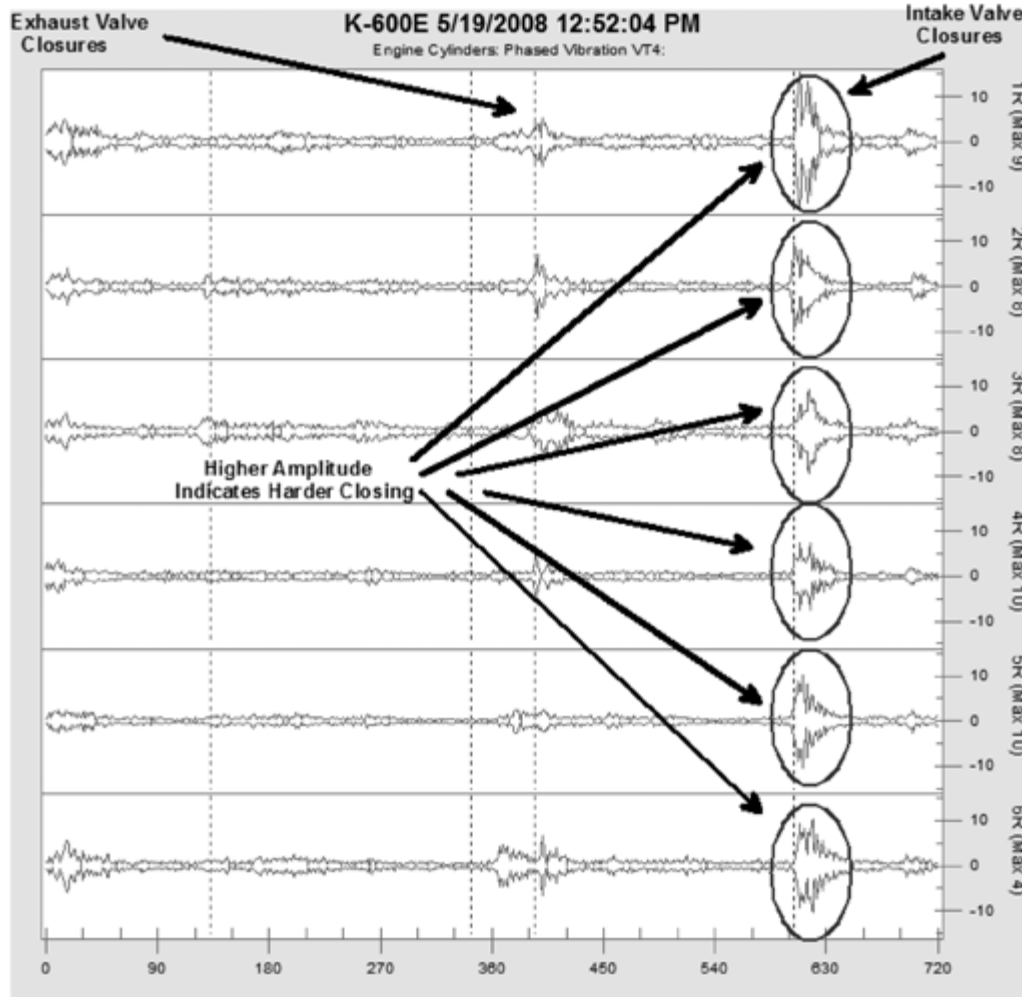
The portable analyzer vibration patterns for the right bank (Figure 7-5) show cylinders 1R, 2R, 3R, 4R, 5R, & 6R have high vibration values for the intake closing events. The Data Acquisition/Fault Detection system reported 4R & 5R as having high vibration values. This appears to be a discrepancy unless the minimum & maximum values for the portable analyzer are taken into account.

Figure 7-5 - Right Bank Vibration Data from Portable Analyzer (Max Values)

Prior to gathering data using a portable analyzer, a valve adjustment was performed. It was subsequently determined that the right side valves were improperly adjusted, which would account for the consistently high vibration on the right side.

Studying the minimum & maximum vibration levels recorded by the portable analyzer, it can be seen that there is variation in the min & max values. The Data Acquisition/Fault Detection System algorithms are specifically designed to filter these variations. Only sustained events that exceed a threshold are reported as problems.

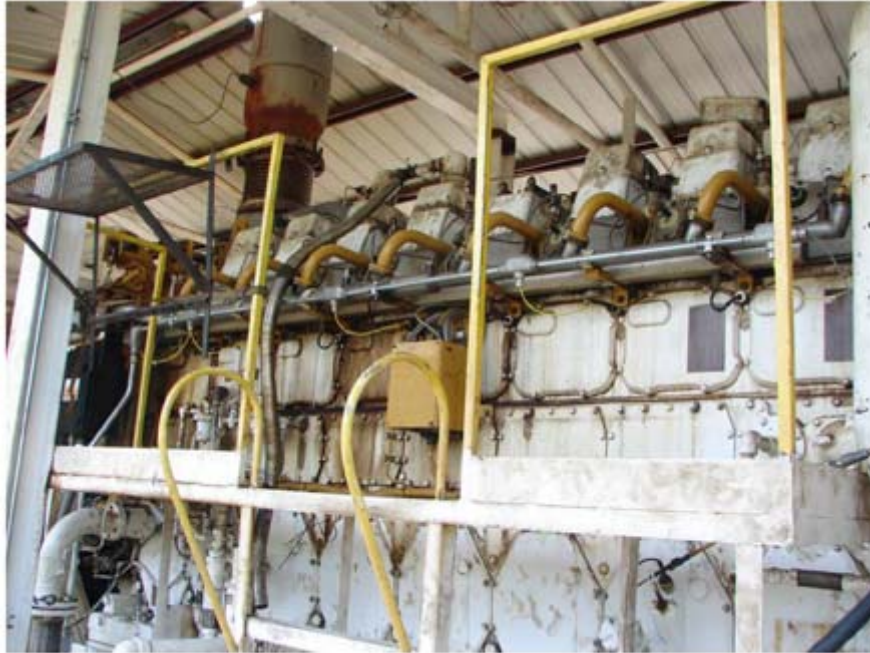
Figure 8-1 - Caterpillar 3608 Engine Under Test

The Data Acquisition/Fault Detection System was mounted on a Caterpillar 3608 engine. This is a turbocharged inline-8 cylinder engine. Accelerometers were mounted between cylinders using studs. Figure 8-1 (above) shows the engine used for testing. Figure 8-2 (below) shows the accelerometer layout for this engine.

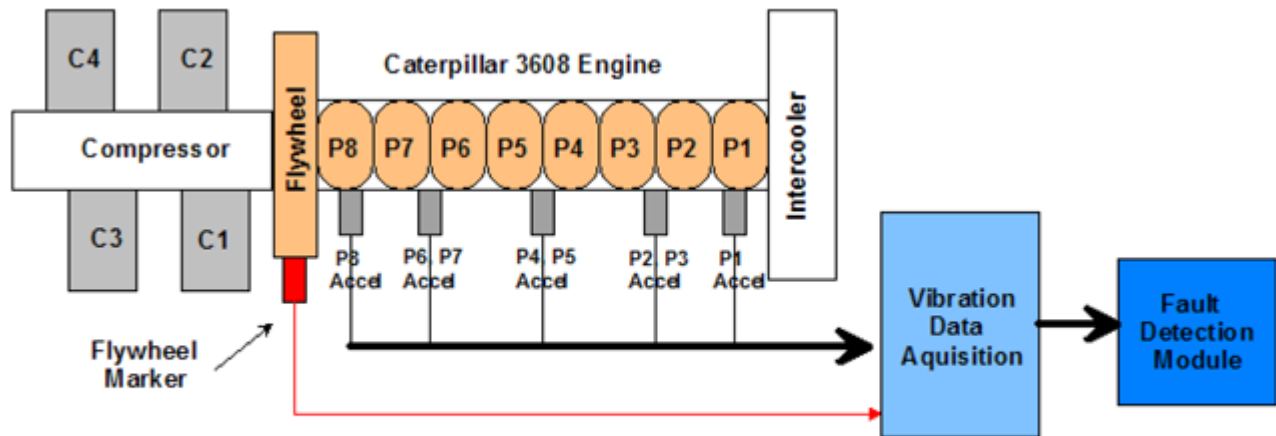
Figure 8-2 - Accelerometer Layout for the Caterpillar 3608 Engine

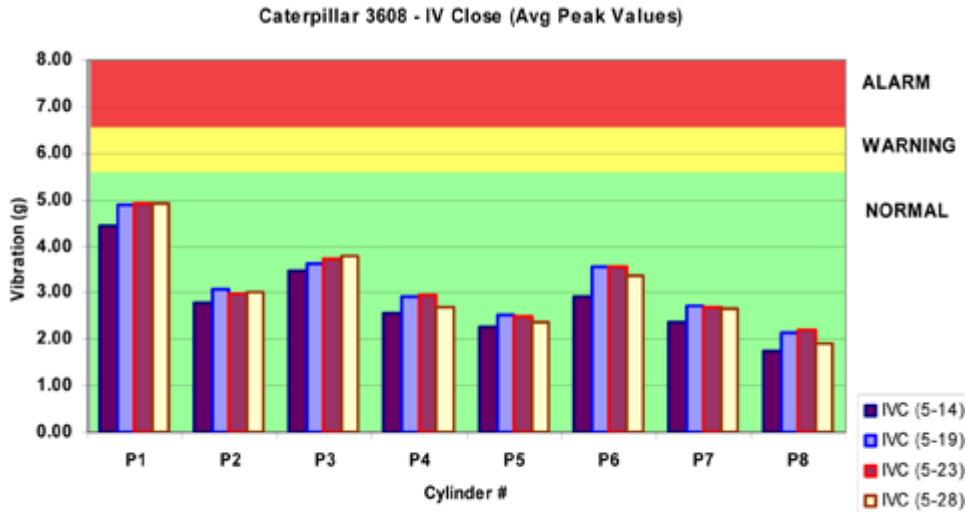
The data gathered in Figure 8-3 & Figure 8-4 are snapshots of the data used by the Fault Detection Module. Average vibration levels are plotted for each cylinder head, as well as the warning and alarm levels determined by the system.

Figure 8-3 - Intake Valve (IV) Closure - Summary of Vibration Levels
Caterpillar 3608 - EV Close (Avg Peak Values)

Amplitudes for each cylinder are shown, along with the alarm bands normal (green), warning (yellow) and alarm (red).

In this case, snapshots of the vibration levels taken on 4 different dates show that none of the vibration amplitudes exceed the normal level. Also, the data shows a high degree of consistency for all 4 snapshots. No alerts were reported by the Fault Detection Module, which supports the snapshot data shown in Figure 8-3 & Figure 8-4.

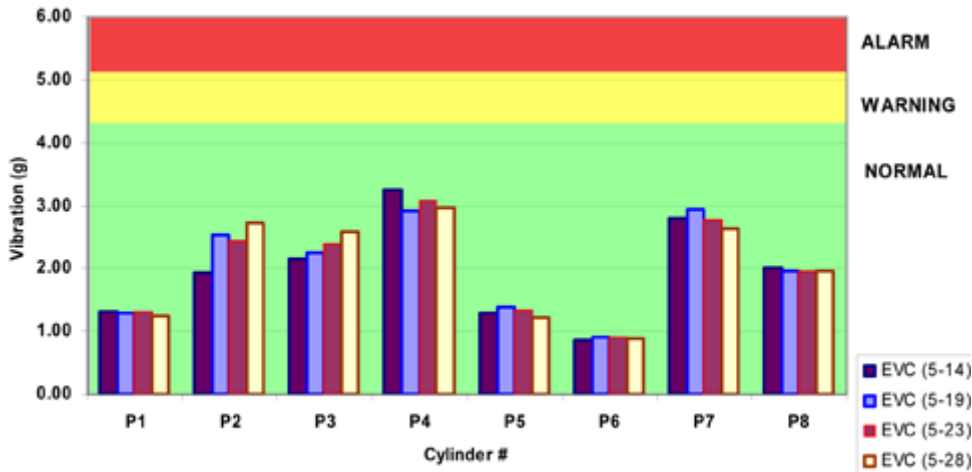
Figure 8-4 - Exhaust Valve (EV) Closure - Summary of Vibration Levels

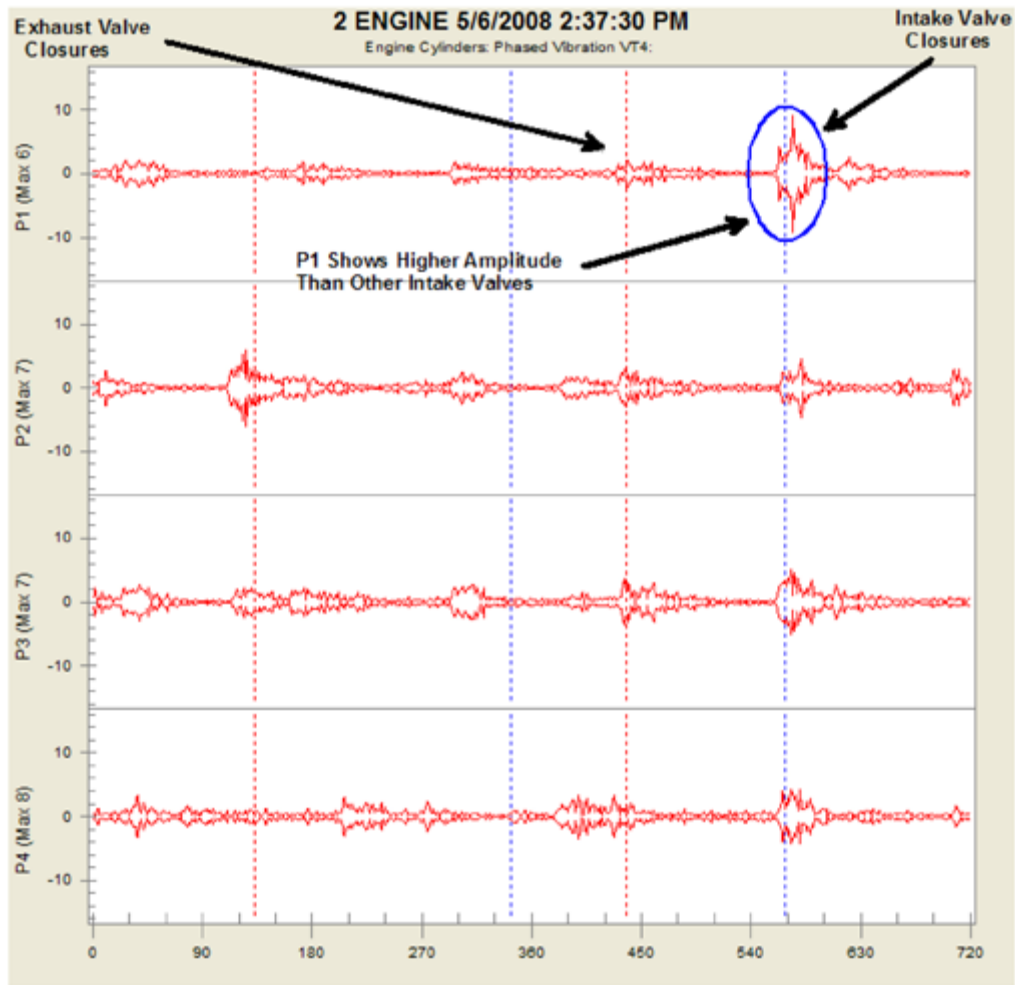
Figure 8-5 – P1 – P4 Vibration Data from Portable Analyzer (Max Values)

These patterns show a higher peak vibration for P1 Intake Close. This higher vibration can also be seen in the data taken by the Data Acquisition System. However, in the case of the Fault Detection System, the warning & alarm thresholds were set to a value that sustained vibration events caused by this valve closure did not exceed.

As before, a portable analyzer was used to determine if the vibration patterns from the analyzer are consistent with the fact that the Fault Detection Module is not reporting problems with the valve closing events. Figure 8-5 & Figure

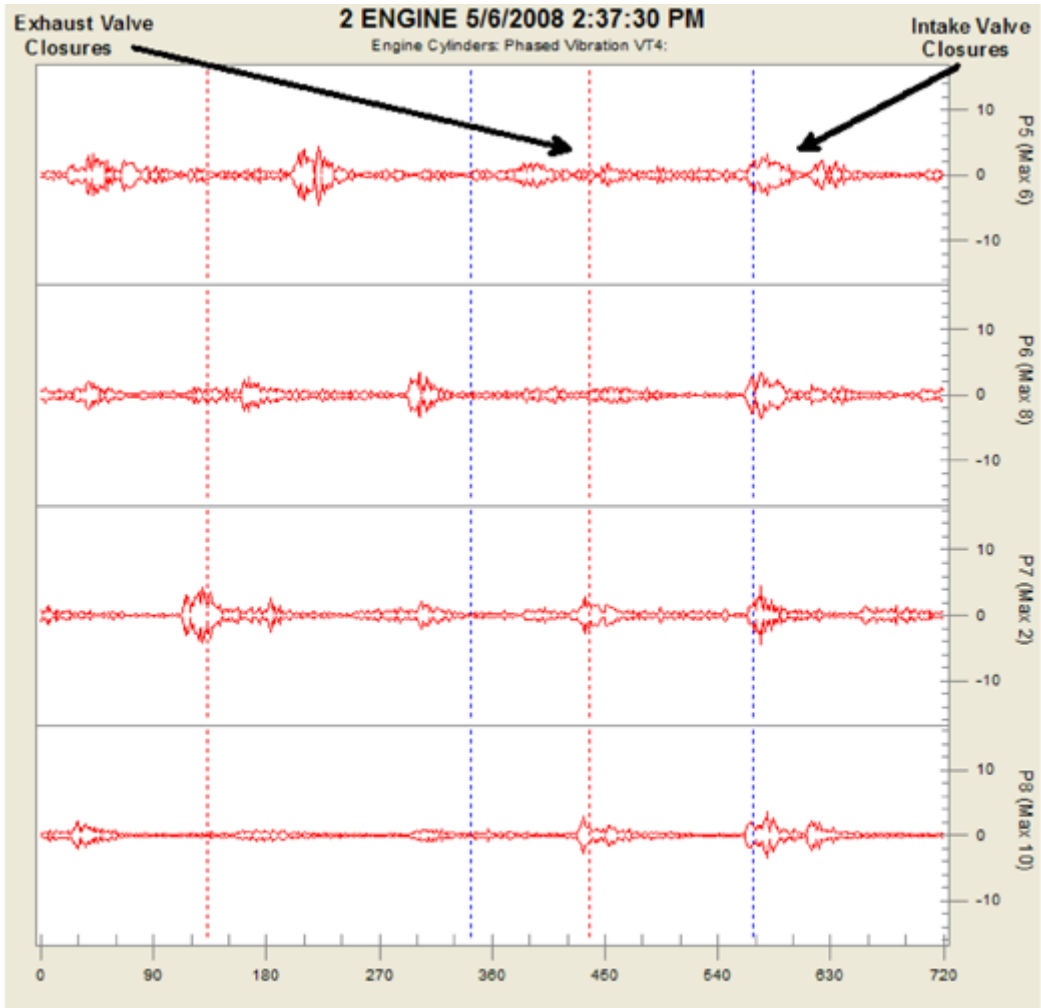
Figure 8-6 - P5 – P8 Vibration Data from Portable Analyzer (Max Values)

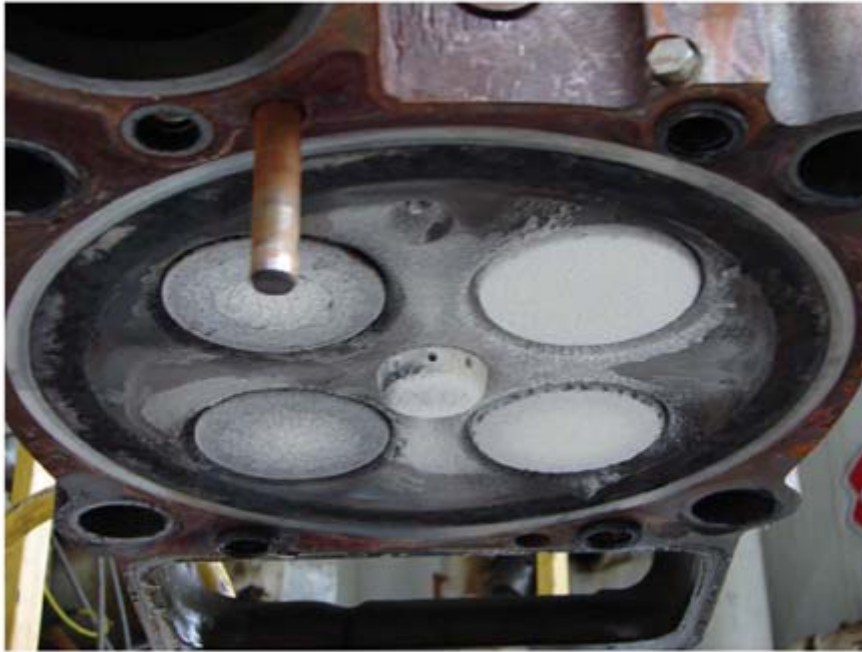
Figure 8-7 – Cylinder Head for Caterpillar 3608 Engine

heads removed for scheduled maintenance. In this case, inspection of the valve train components revealed no issues that would lead to imminent failure. This is consistent with the fact that the Data Acquisition/Fault Detection System reported no problems, and the data taken with a portable analyzer also showed no problems. Figure 8-7 shows the combustion chamber for cylinder head P3.
